PEACE AND PLENTY

Rural Historic District Guidelines

REVISED 11.14.22

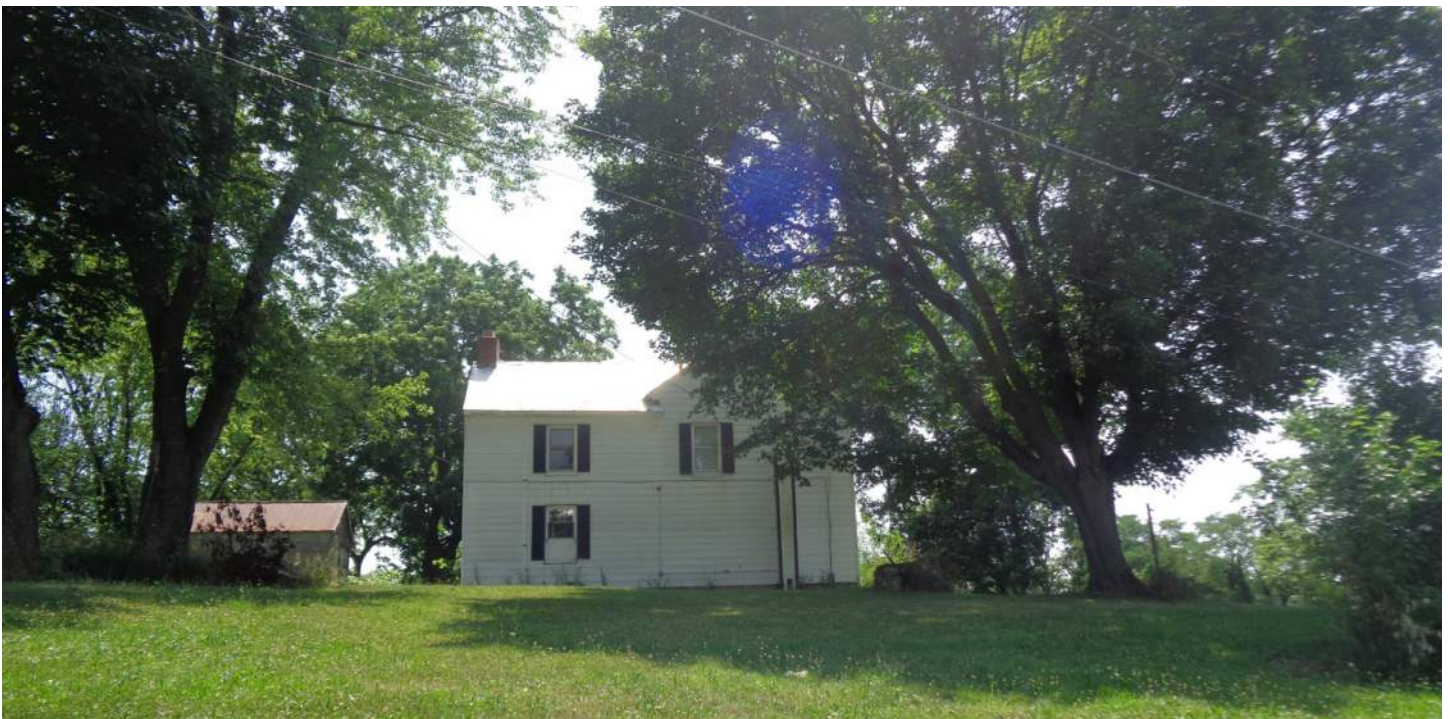
The log cabin at the Wright Downey Farm is covered in siding. Photo by authors.

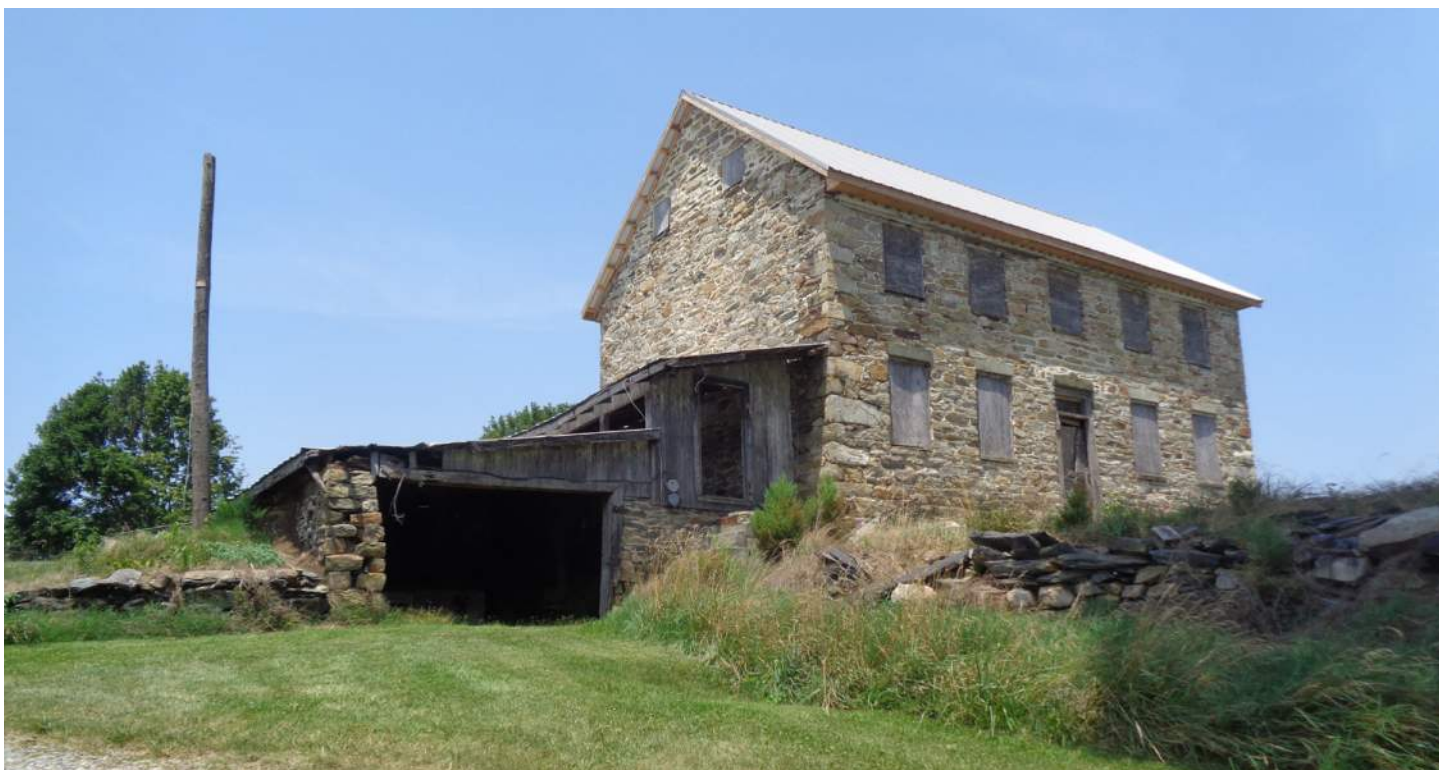
Stone retaining walls extend beyond the walls of the Daniel James house. Photo by authors.

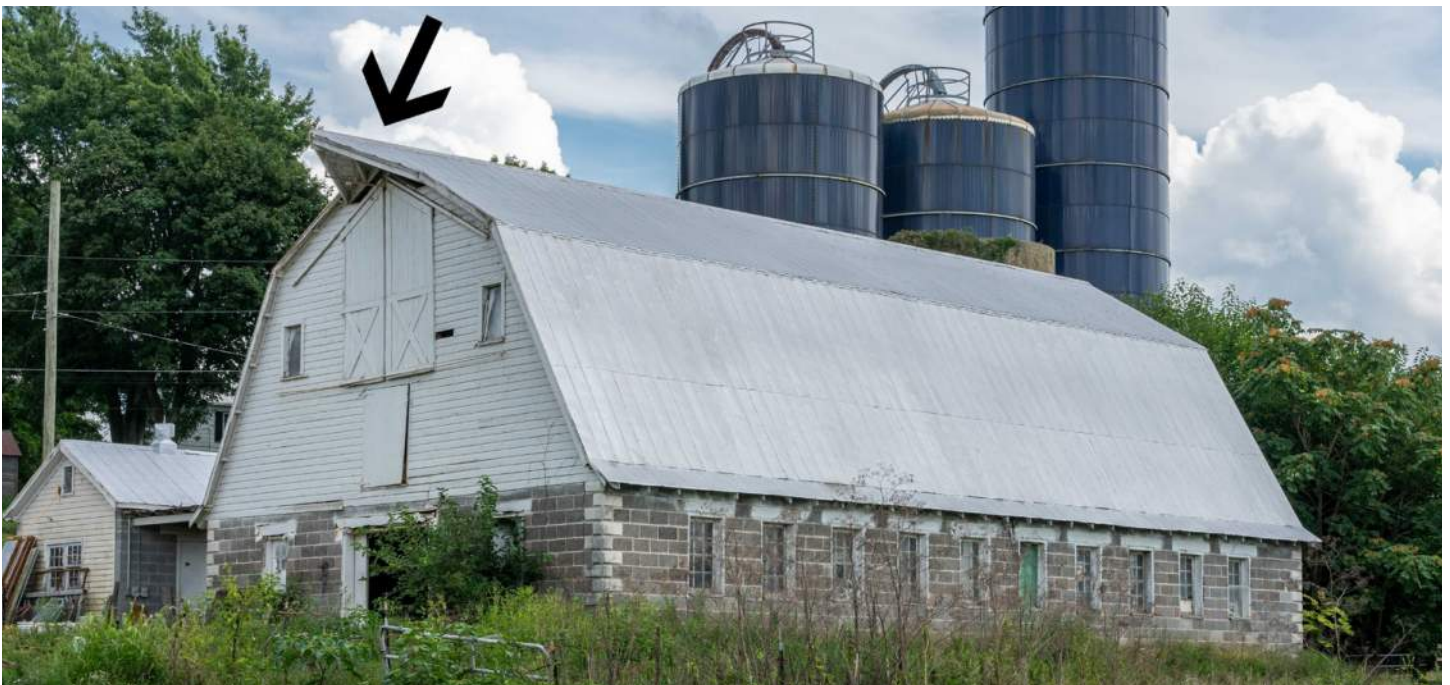
The dairy barn at the Wright Downey Farmstead has a prominent gambrel roof form with a hay hood at the end of the ridge. Photo by Wilson Coudon.

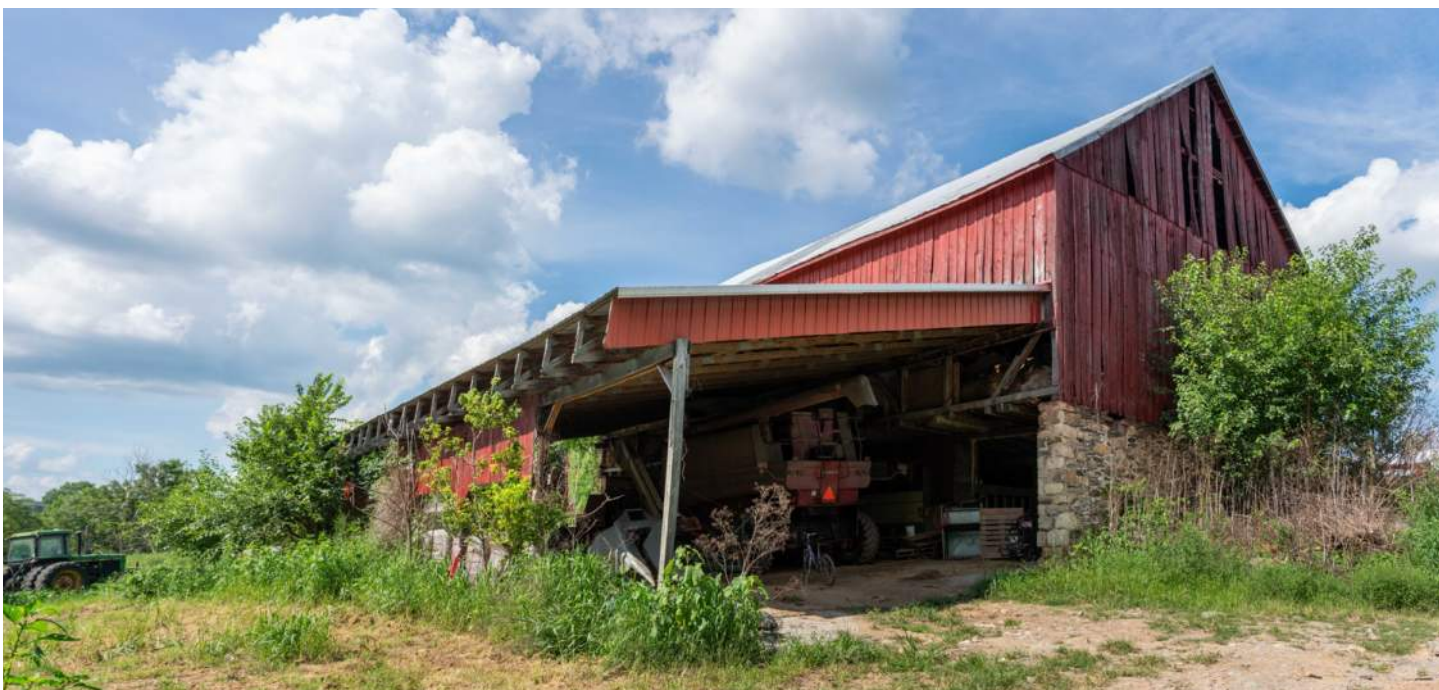
Simple barn forms with gable roofs were often expanded with shorter shed structures like this bank barn at the Wright Downey Farmstead. Photo by Wilson Coudon.

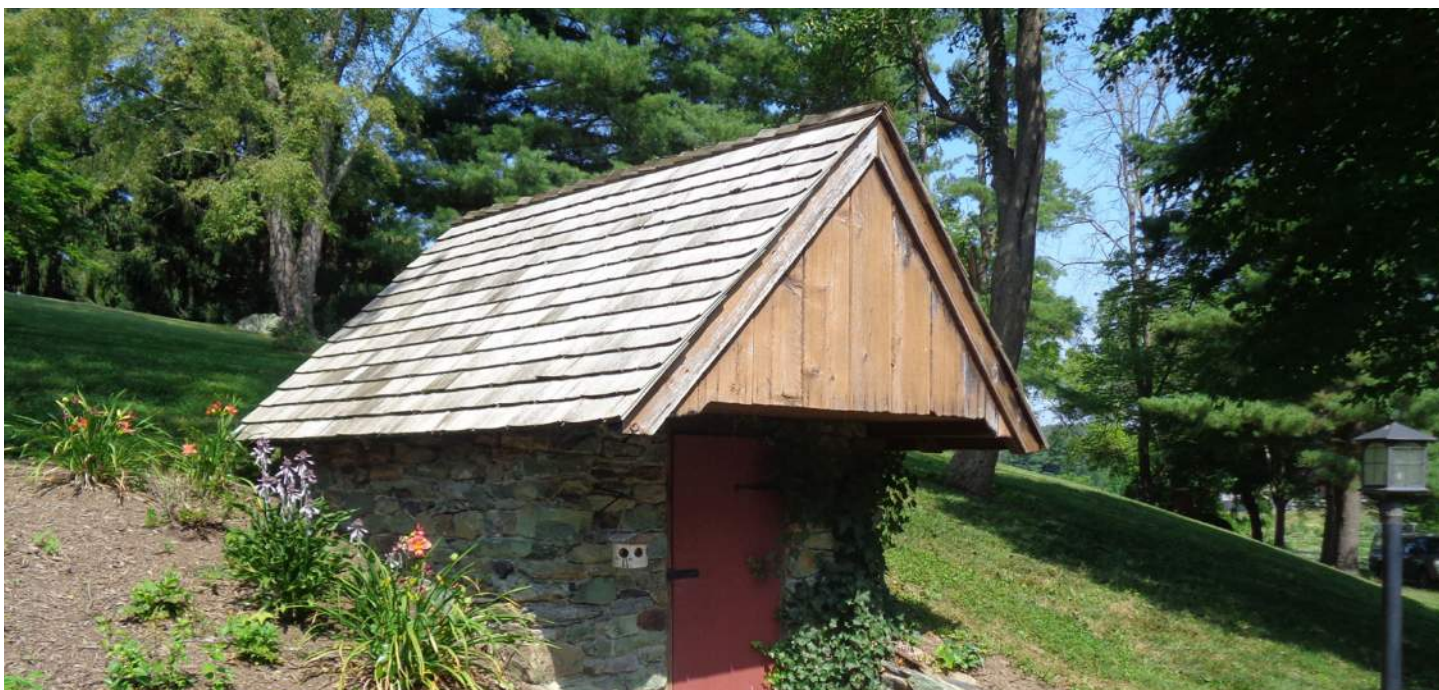
Wood shingle roofing on an ancillary structure at Still Work Farm. Photo by authors.

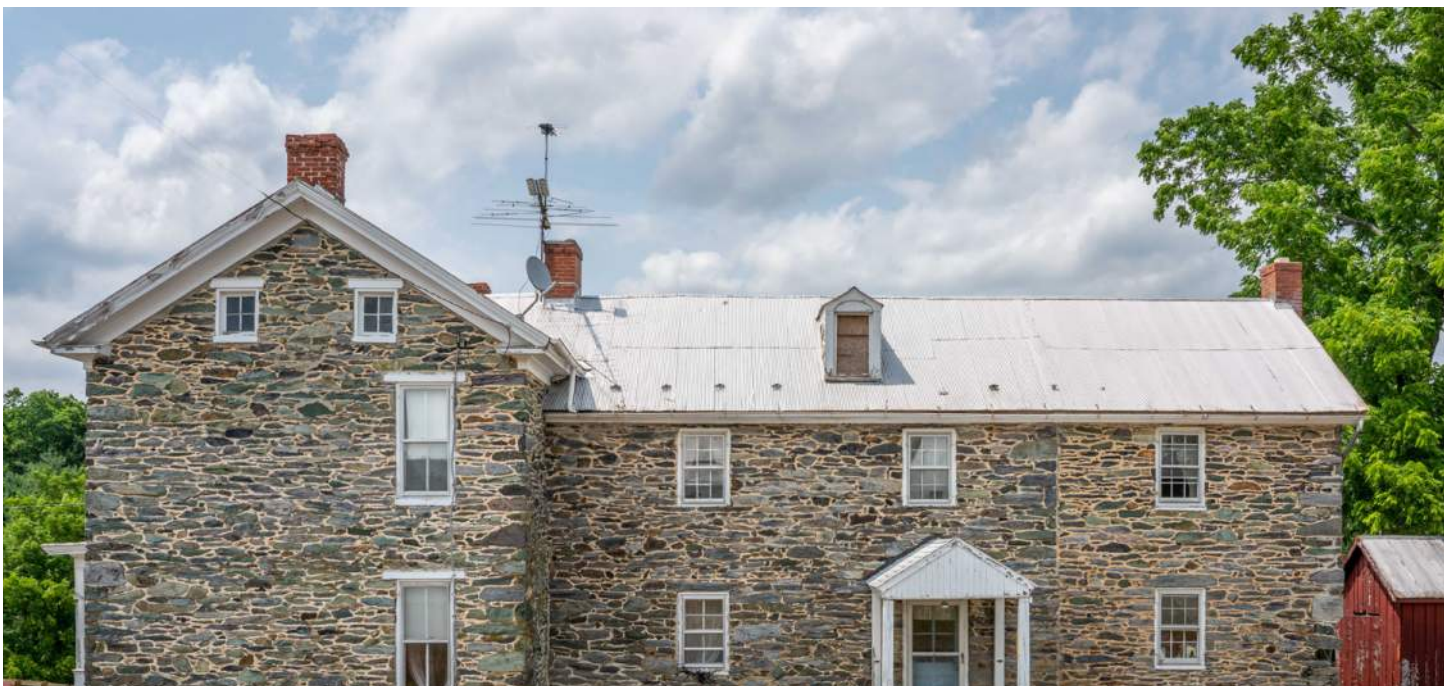
Sheet metal roofing on the Basil Harding farmhouse. Photo by Wilson Coudon.

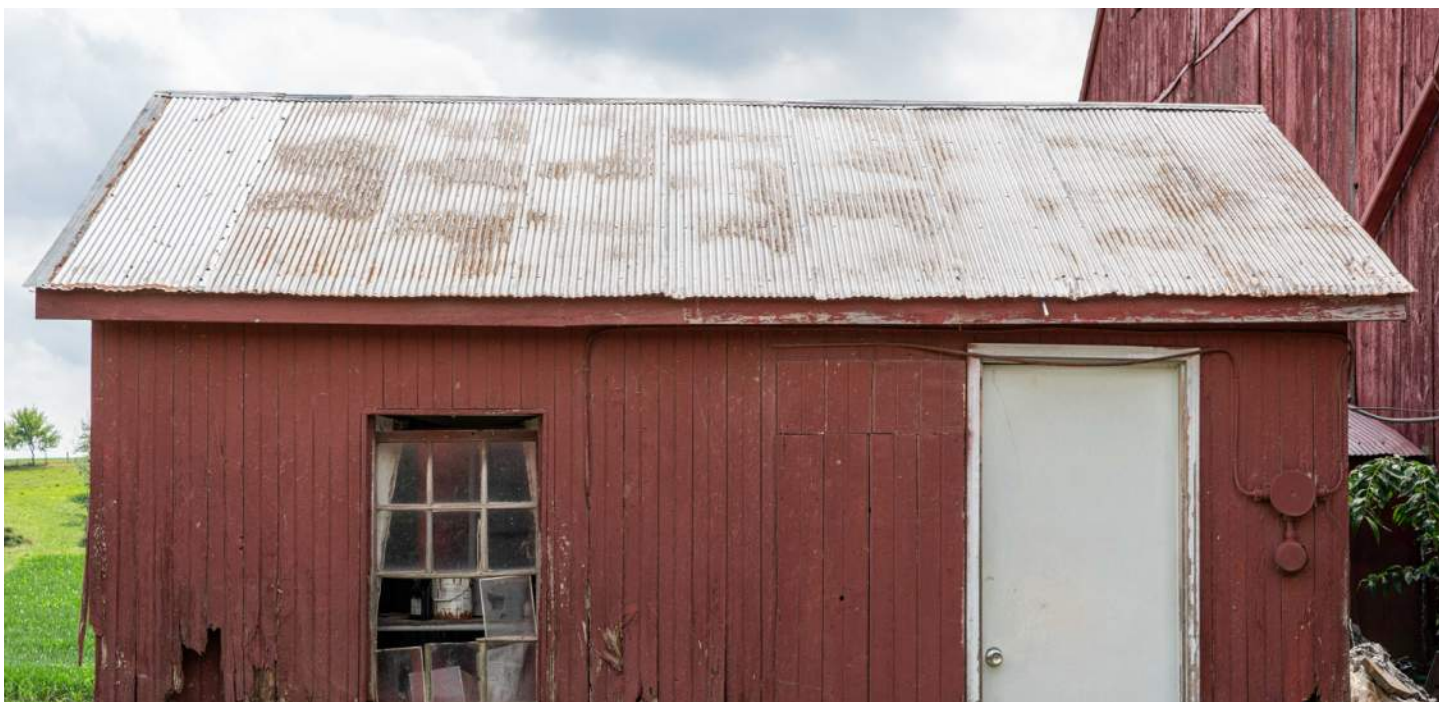
Corrugated metal roofing on this small ancillary structure. Photo by Wilson Coudon.

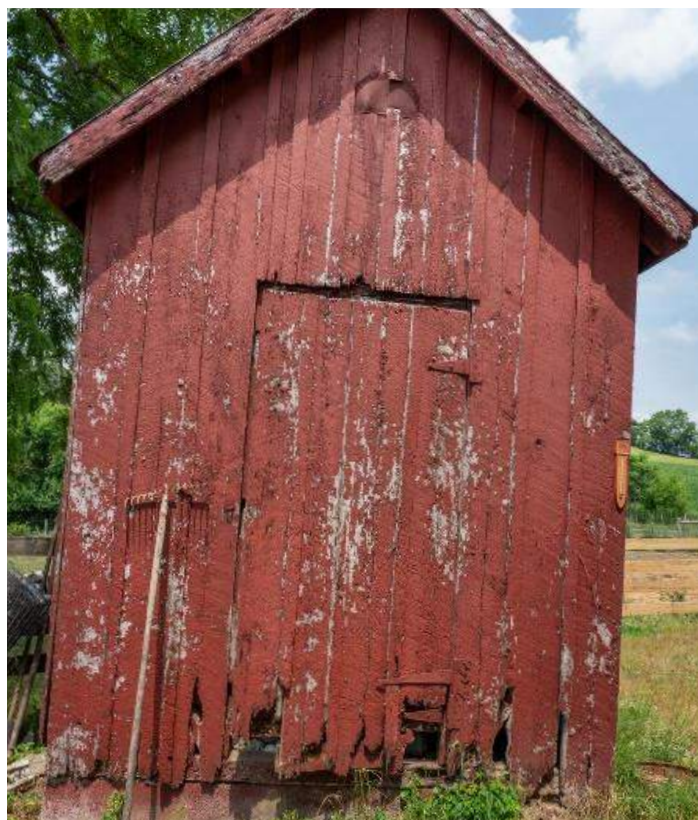
The upper structure of the bank barn at the Wright Downey Farmstead was rebuilt upon its stone foundation walls. Photo by Wilson Coudon.

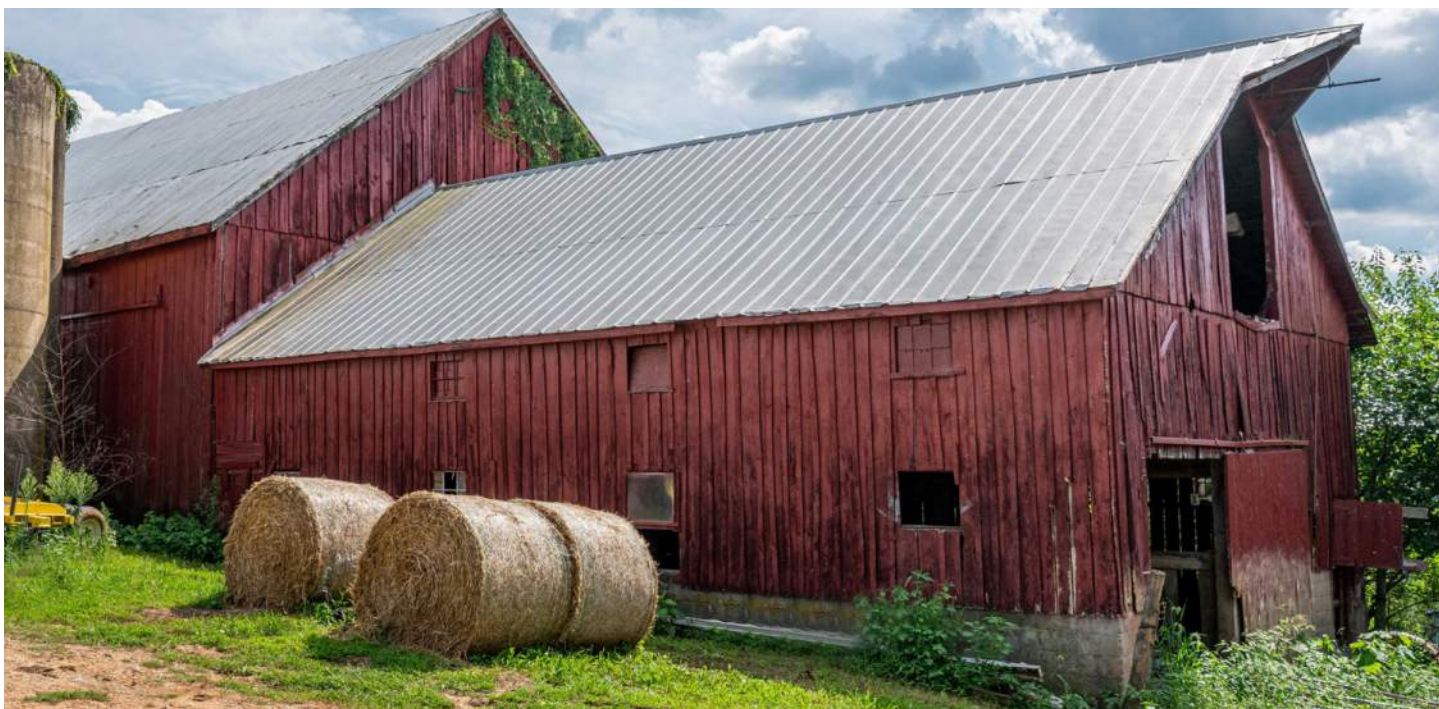
Most of the wood siding found in Peace and Plenty is vertical board-and-battens like that of the bank barn at the William Downey farm. Photo by Wilson Coudon.

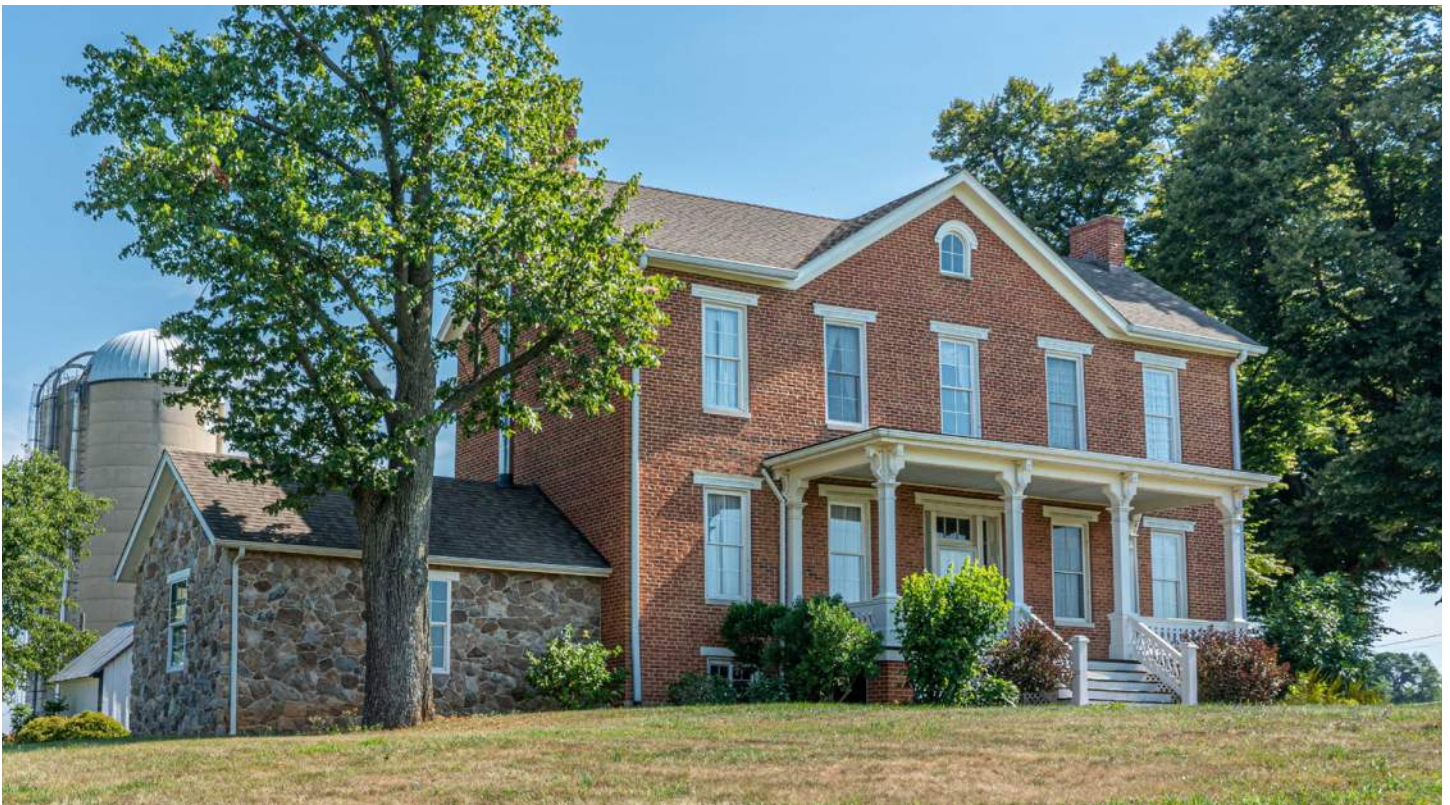
The brick of the Captain Ignatius W. Dorsey farmhouse is laid in a common bond pattern. Photo by Wilson Coudon.

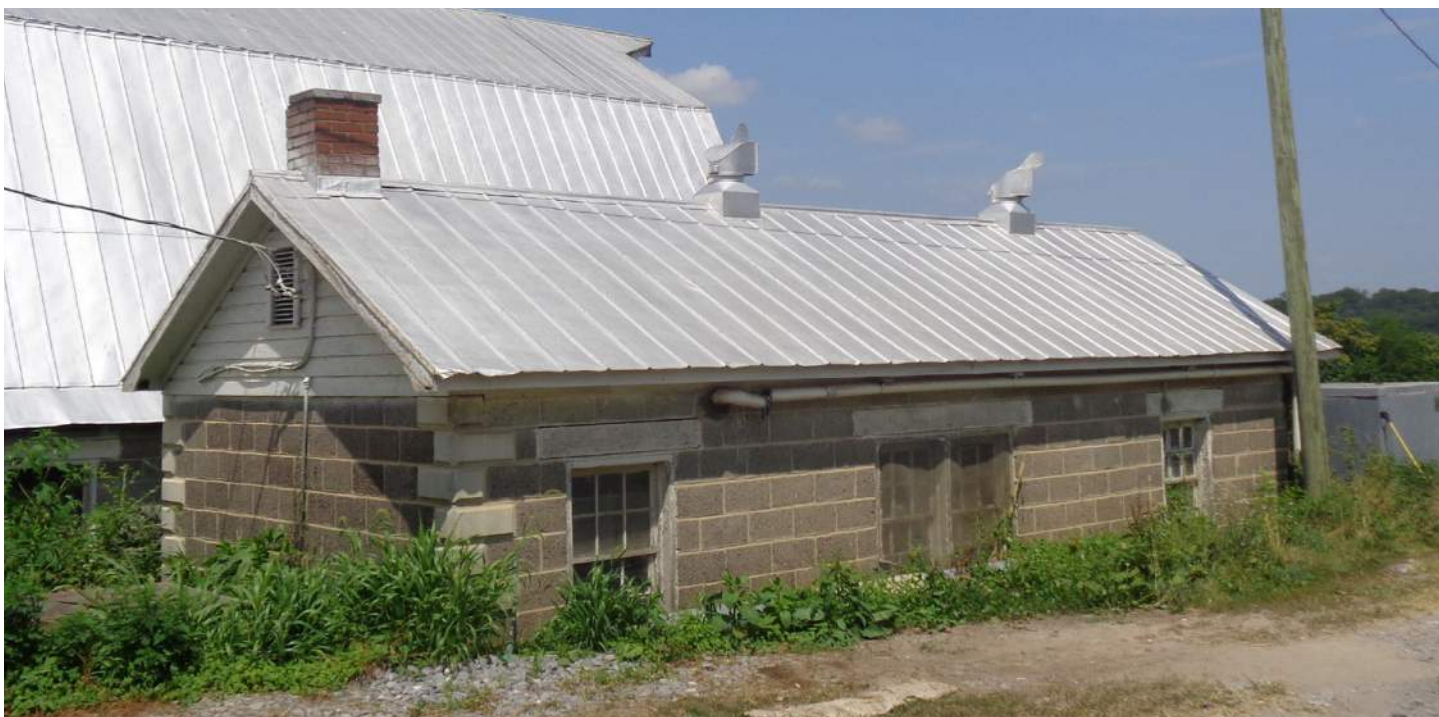
The milk house at the Wright Downey Farmstead has walls made of concrete masonry units. Photo by authors.

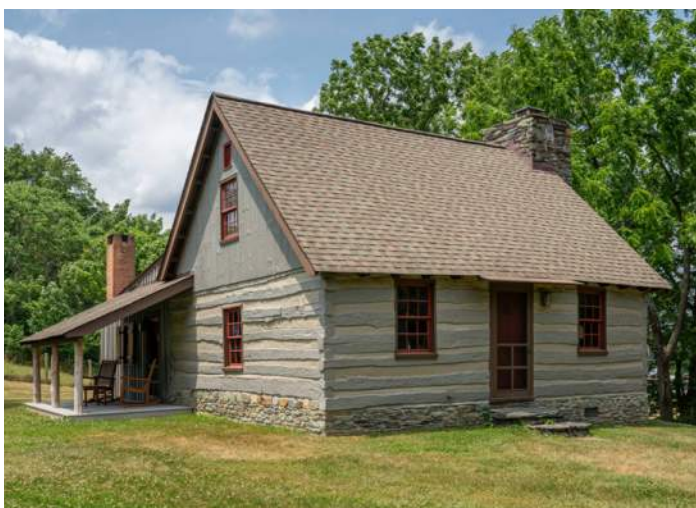
This log cabin at Still Work was constructed in 1970 using traditional methods. Photo by Wilson Coudon.

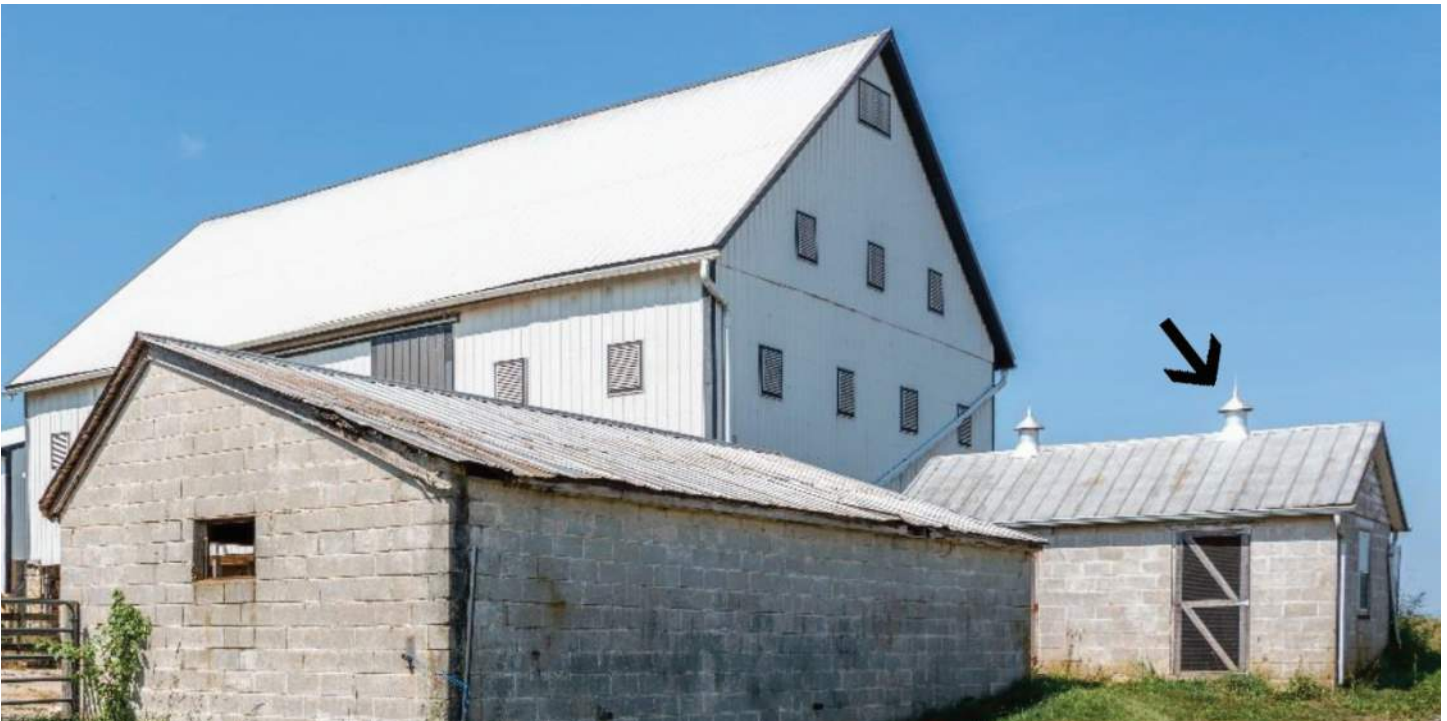
The bank barn at the Captain Ignatius W. Dorsey Farm has been resided in metal and the adjoining milk house has distinctive “oil can” shaped metal vents. Photo by Wilson Coudon.

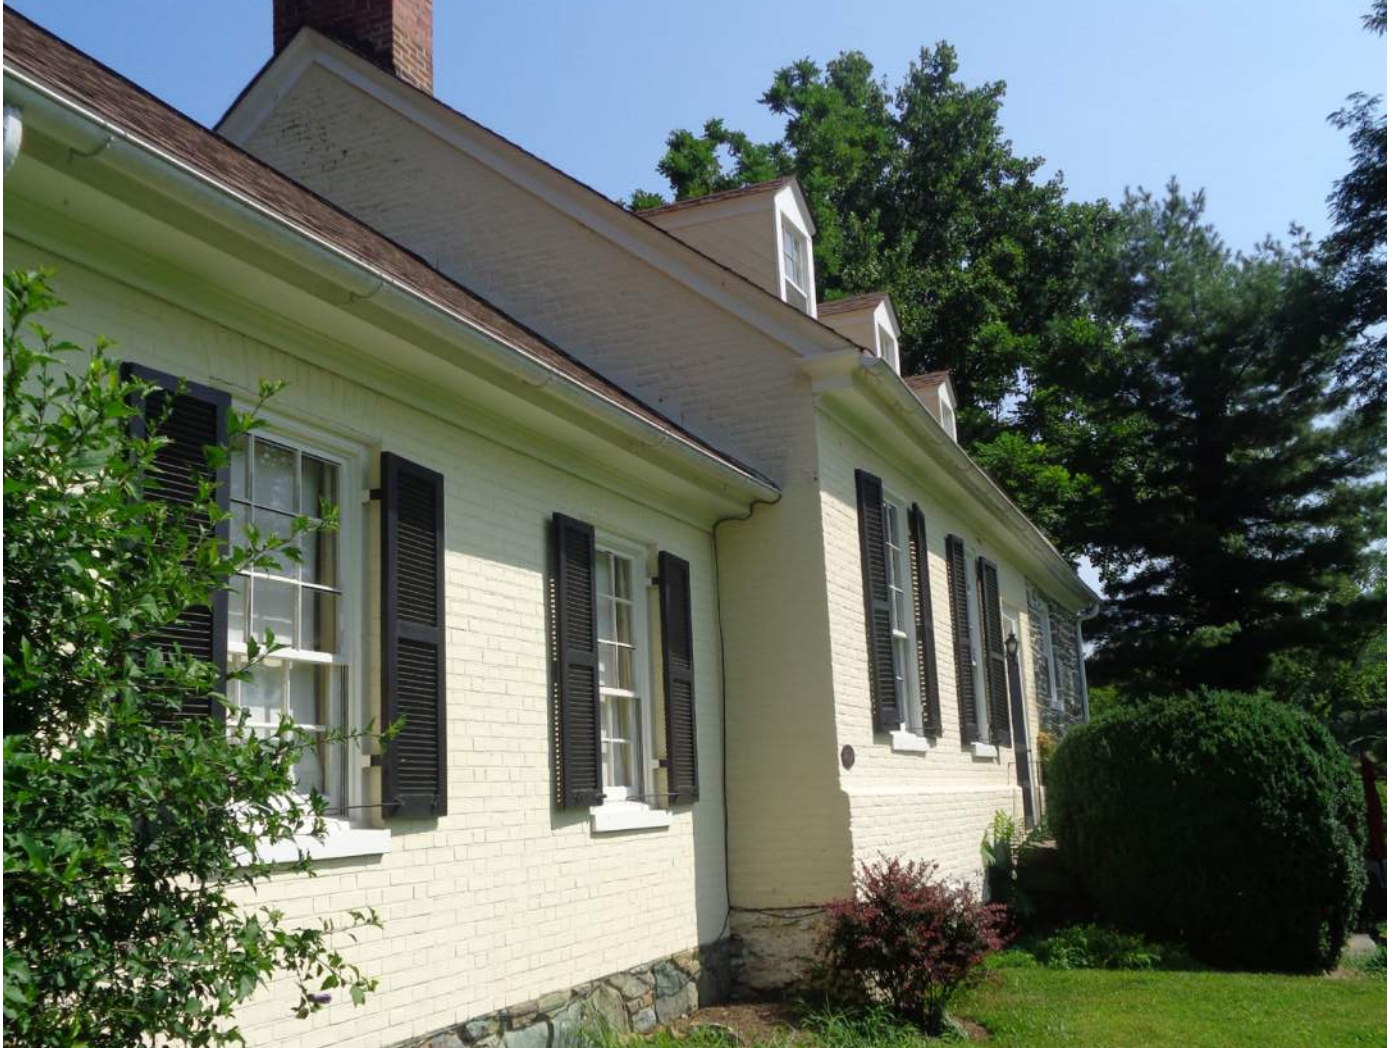
The 1960s brick addition (left) at Still Work is recessed from the original one-and-a-half story section, but the materials and detailing are in keeping with the original. Photo by authors.

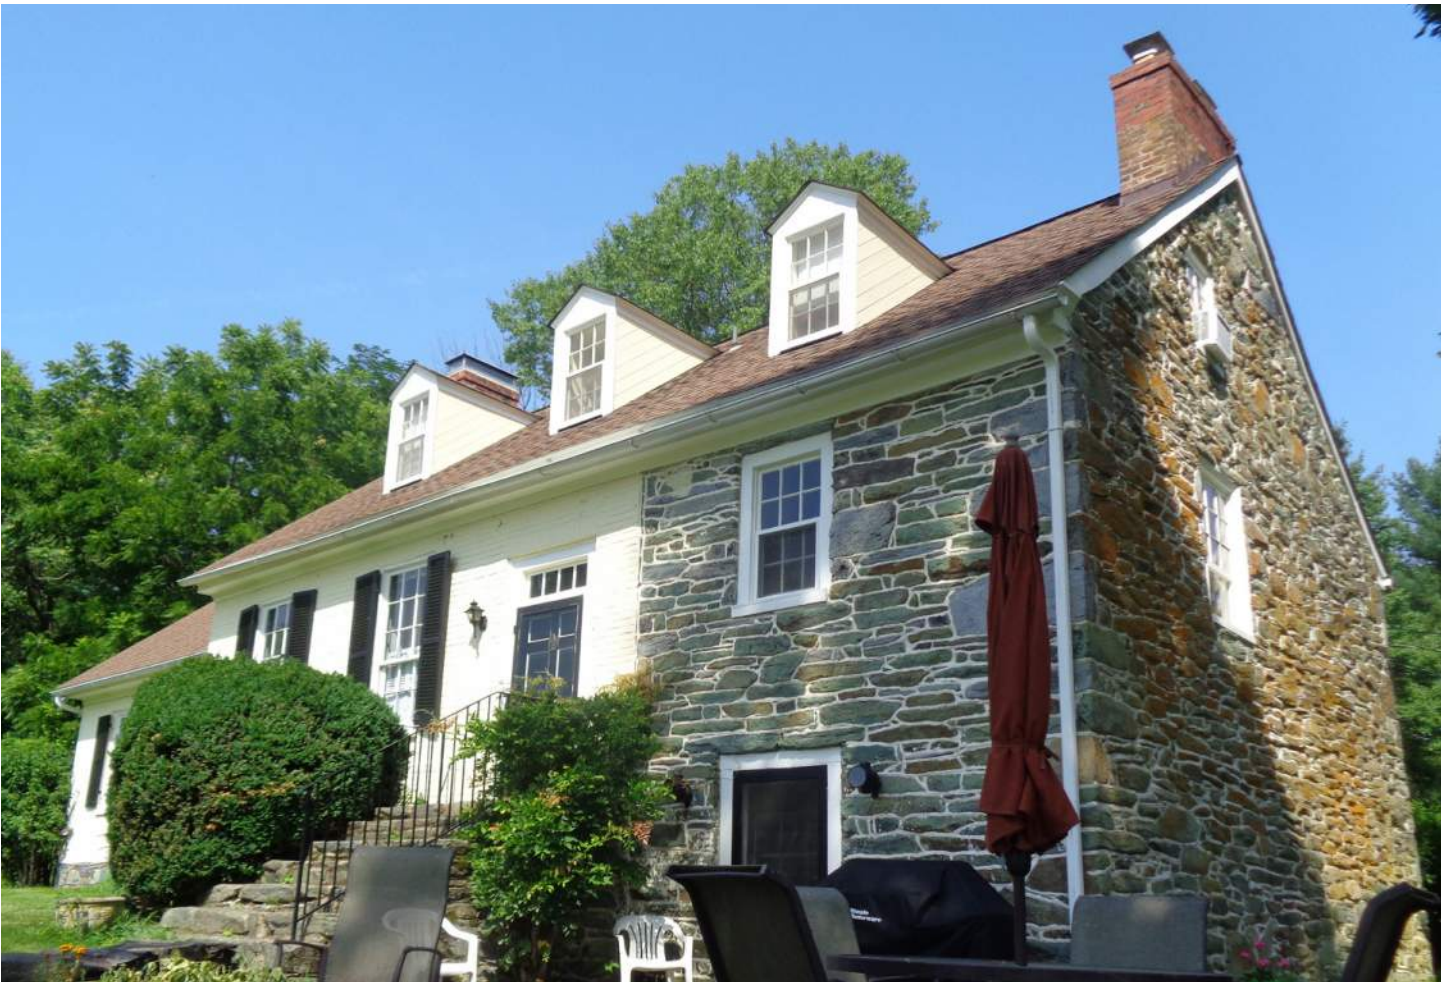
The joint between the original brick of the Still Work farmhouse and an early stone addition. Photo by authors.

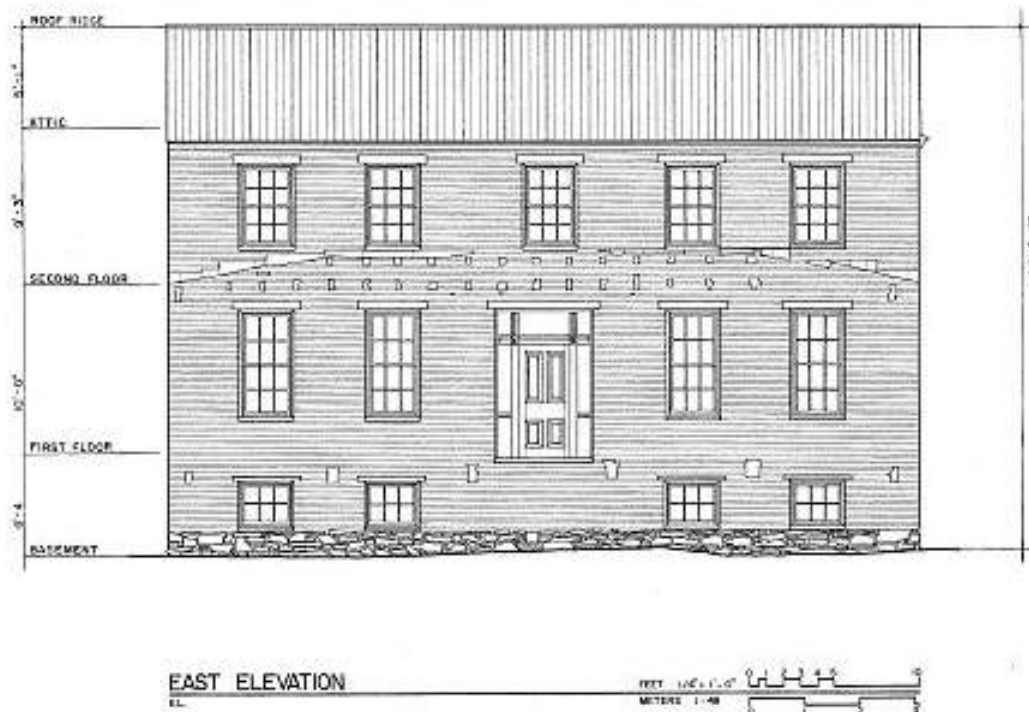
HABS documentation includes floor plans and elevation drawings. This drawing shows part of the HABS documentation on file at the Library of Congress for the Clifton Farm, located off Baker Road in Frederick County.
